SHORELINE RESTORATION PLAN

**76 Clearview Drive (Crystal Lake), Trent Lakes
Lot 60, Registered Plan 11, Geographic Township of Galway
County of Peterborough, Ontario**

July 8, 2024

Reference No.: R24-1147

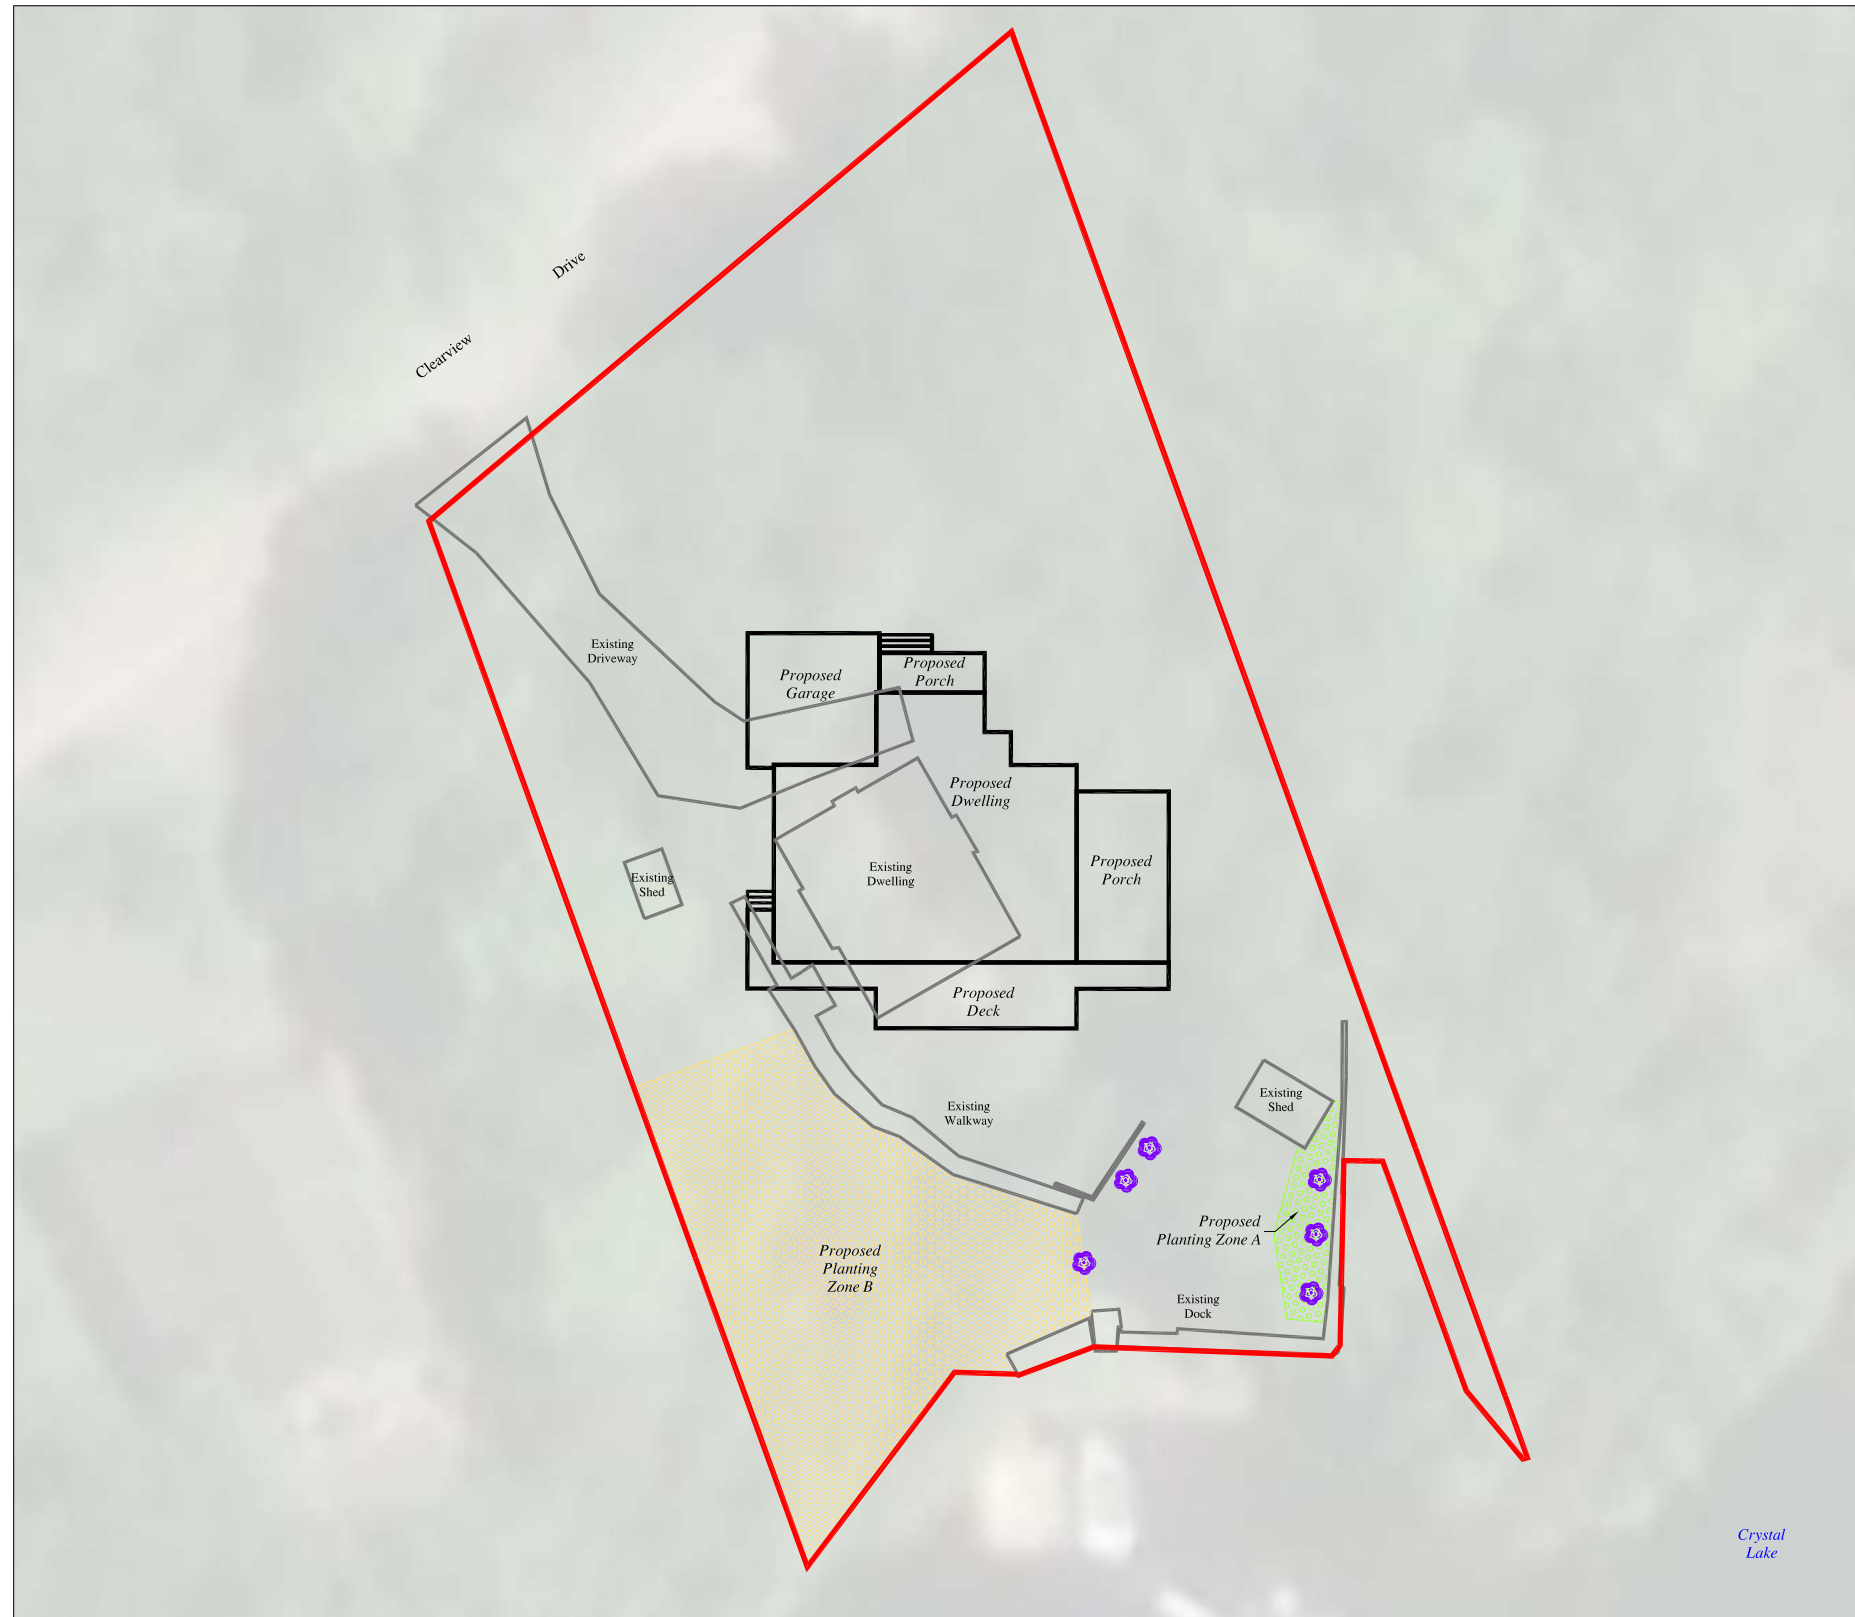
| DRAWN | R24-1147 | FIGURE NO. 1 |

TITLE
RESTORATION PLAN

Site assessments, in conjunction with our associate biologists Blazing Star Environmental, were completed to ascertain the prevailing soil and vegetation communities on the subject property in order to provide a suitable planting plan specific to the prevailing site conditions (Refer to Figure 1 - Restoration Plan).

These planting areas ‘Planting Zone A’ is currently lawn and a suitable area for shrub and moisture tolerant wildflower planting. ‘Planting Zone B’ is located within the existing forest and is suitable for woodland wildflowers and herbs (Refer to Figure 1 - Restoration Plan and Appendix A).

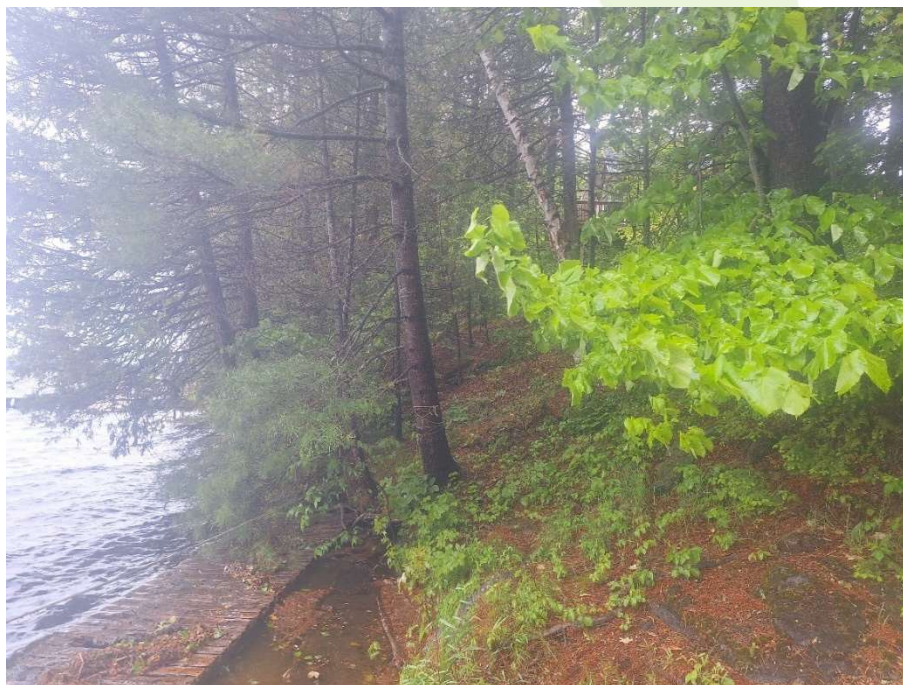
On the western side of the Site, the shoreline and upland area are forested. It is a mostly young community, with a few scattered mature trees. Tree species observed include Eastern White Cedar (*Thuja occidentalis*), Balsam Fir (*Abies balsamea*), Red Pine (*Pinus resinosa*), Eastern White Pine (*Pinus strobus*), American Elm (*Ulmus americana*), Basswood (*Tilia americana*), Silver Maple (*Acer saccharinum*), and White Birch (*Betula papyrifera*). By the shore, the forest ground vegetation is approximately 25%, consisting of common woodland species. Further up the slope, the groundcover is approximately 75% and dominated entirely by Lesser Periwinkle (*Vinca minor*).

Photo 1: Looking east at the forest community along the shoreline on-site.

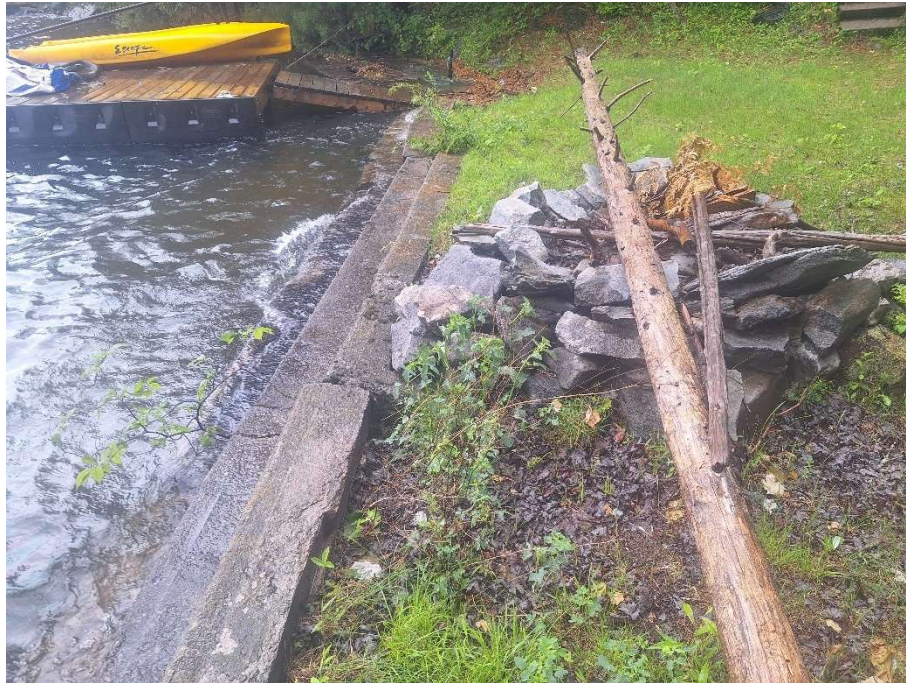
The central portion of the shoreline is lawn, with a border of concrete steps also functioning as erosion prevention. A few moisture-tolerant shrubs are beginning to grow along its edge. There is also a large firepit on the lawn. Areas of exposed soil in the lawn are sandy loam. Uphill from the lawn there are gardens, exposed bedrock, and a slope also dominated by Lesser Periwinkle.

Photo 2: Lawn community and fire pit on the Site, bordered by concrete steps along the shoreline.

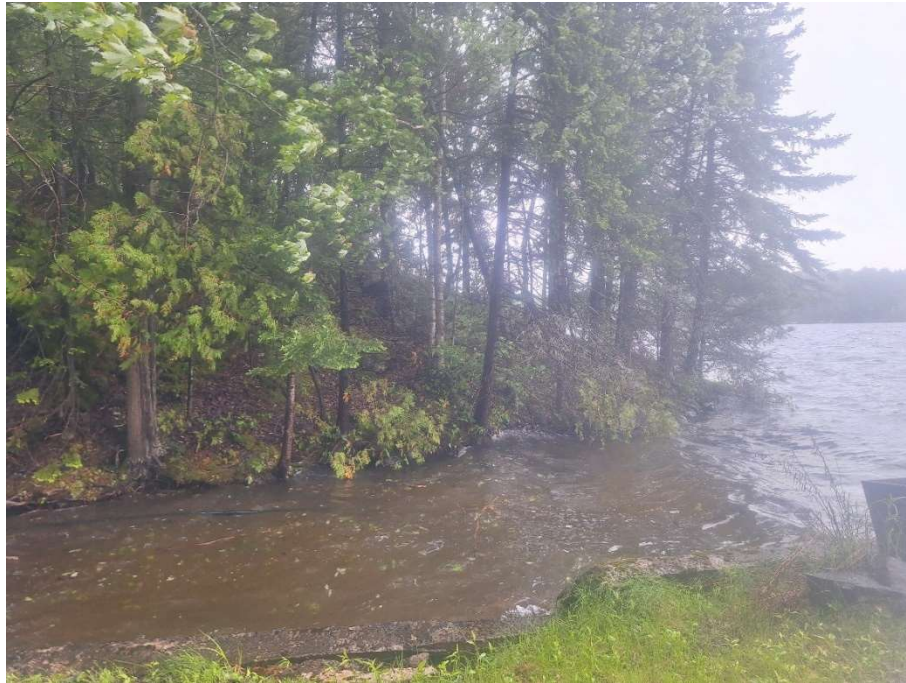
The eastern border of the Site is treed, with similar species composition to the western portion, comprised primarily of cedar, pine, and maple. There is a channel on this side flowing into Crystal Lake. Near the mouth of the lake, the channel is wide with a concrete border on the lawn-side and a forested slope to the east. Upstream, the channel narrows and becomes less defined.

Photo 4: Looking east at the treed border of the Site and the mouth of the channel draining into Crystal Lake.

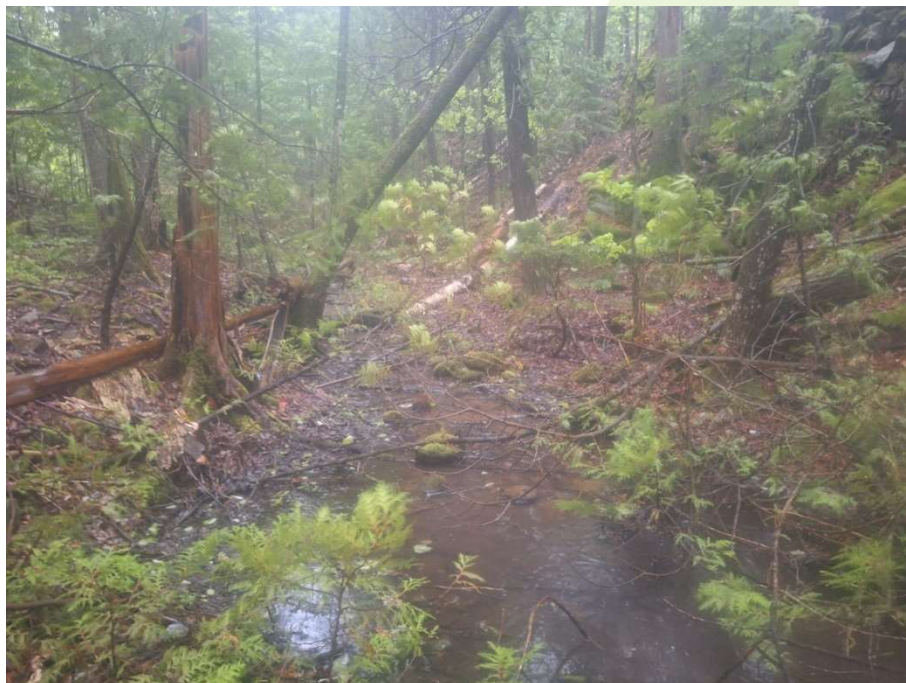
Photo 5: Upstream reach of the channel on the eastern border of the Site.

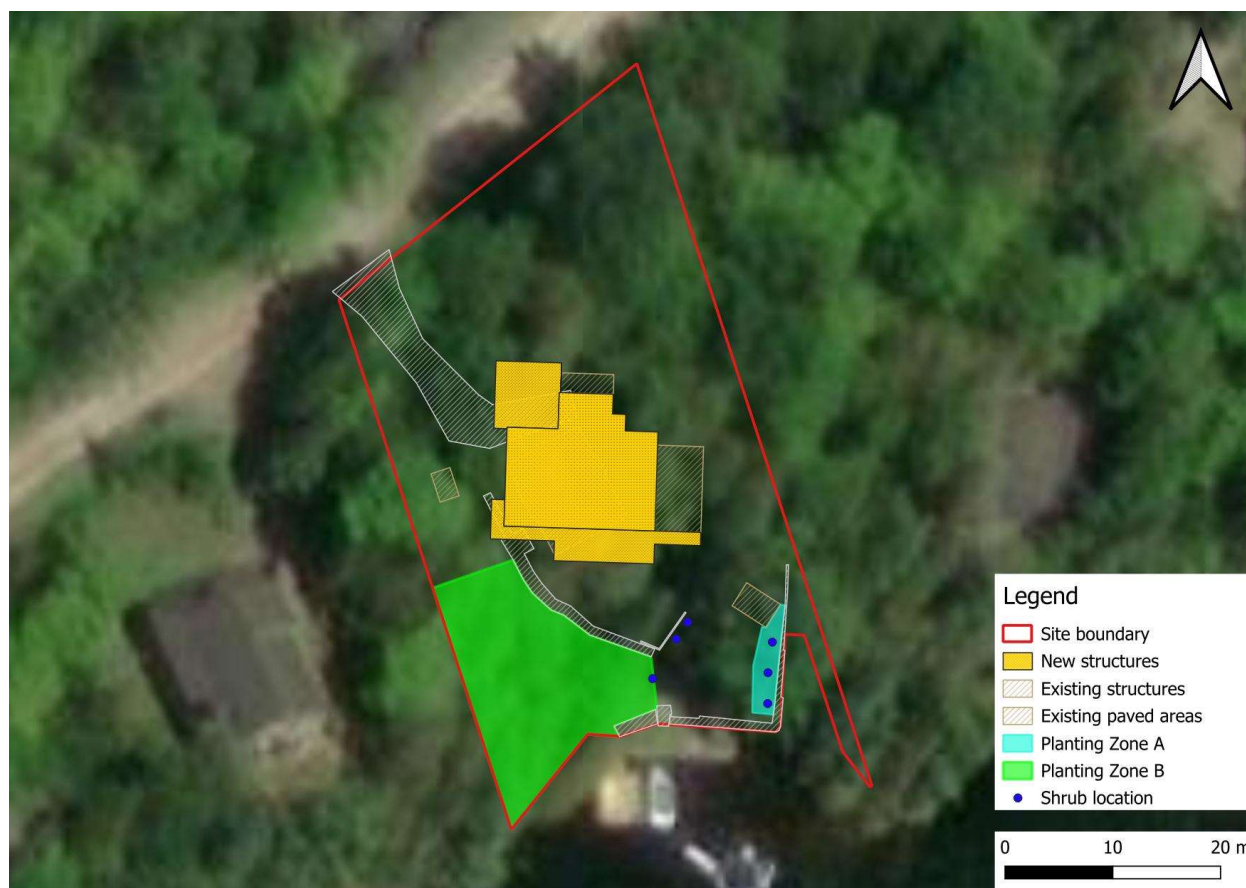
Figure 1: Site plan and planting locations on-site. 'Planting Zone A' (blue) represents areas suitable for planting shrubs and moisture/light tolerant wildflower species. 'Planting Zone B' (green) represents areas suitable for woodland flower and herb planting.

In order to maintain the landowner's use of the shoreline (i.e., access to dock, firepit) while ensuring continued shoreline stability, improved native biodiversity, and improved shoreline habitat, we have recommended that planting efforts be directed along the west border of the channel and in areas that have become dominated by non-native species. These plantings will also serve to reduce sediment and nutrient run off into the lake, thereby improving fish habitat in the adjacent Crystal Lake. These planting areas extend approximately 15 m towards the cottage to the east and 20 m towards the cottage to the west. 'Planting Zone A' is currently lawn and a suitable area for shrub and moisture tolerant wildflower planting. 'Planting Zone B' is located within the existing forest and is suitable for woodland wildflowers and herbs. These planting areas are shown on Figure 1 below.

A minimum of 6 shrubs are recommended to be planted in the approximate locations described in Figure 1. Additionally, if tree removal occurs within the building footprint, it is highly recommended to replace the number removed to enhance the shoreline and forest habitat. Suitable replacement species include several of the native trees already present on-site: Eastern White Cedar, Eastern White Pine, and Silver Maple. Recommended native shrub and wildflower species selected for this shoreline restoration planting are provided in Table 1, Table 2, and Table 3. Photos of each species are provided in Appendix A and Appendix B. The plants selected are native to the Nogies Creek (containing Crystal Lake) watershed and are suited for the soil and moisture conditions observed on the Site.
