Re: Ministry of Natural Resources and Forestry Letter Regarding Species At Risk for Tecasy Ranch Official Plan and Zoning By-law Amendments
Cambium Reference No.: 5154-001

Zoning Sketch Detail

Tecasy Ranch - OPA and ZBA

REPTILE AND AMPHIBIAN EXCLUSION FENCING

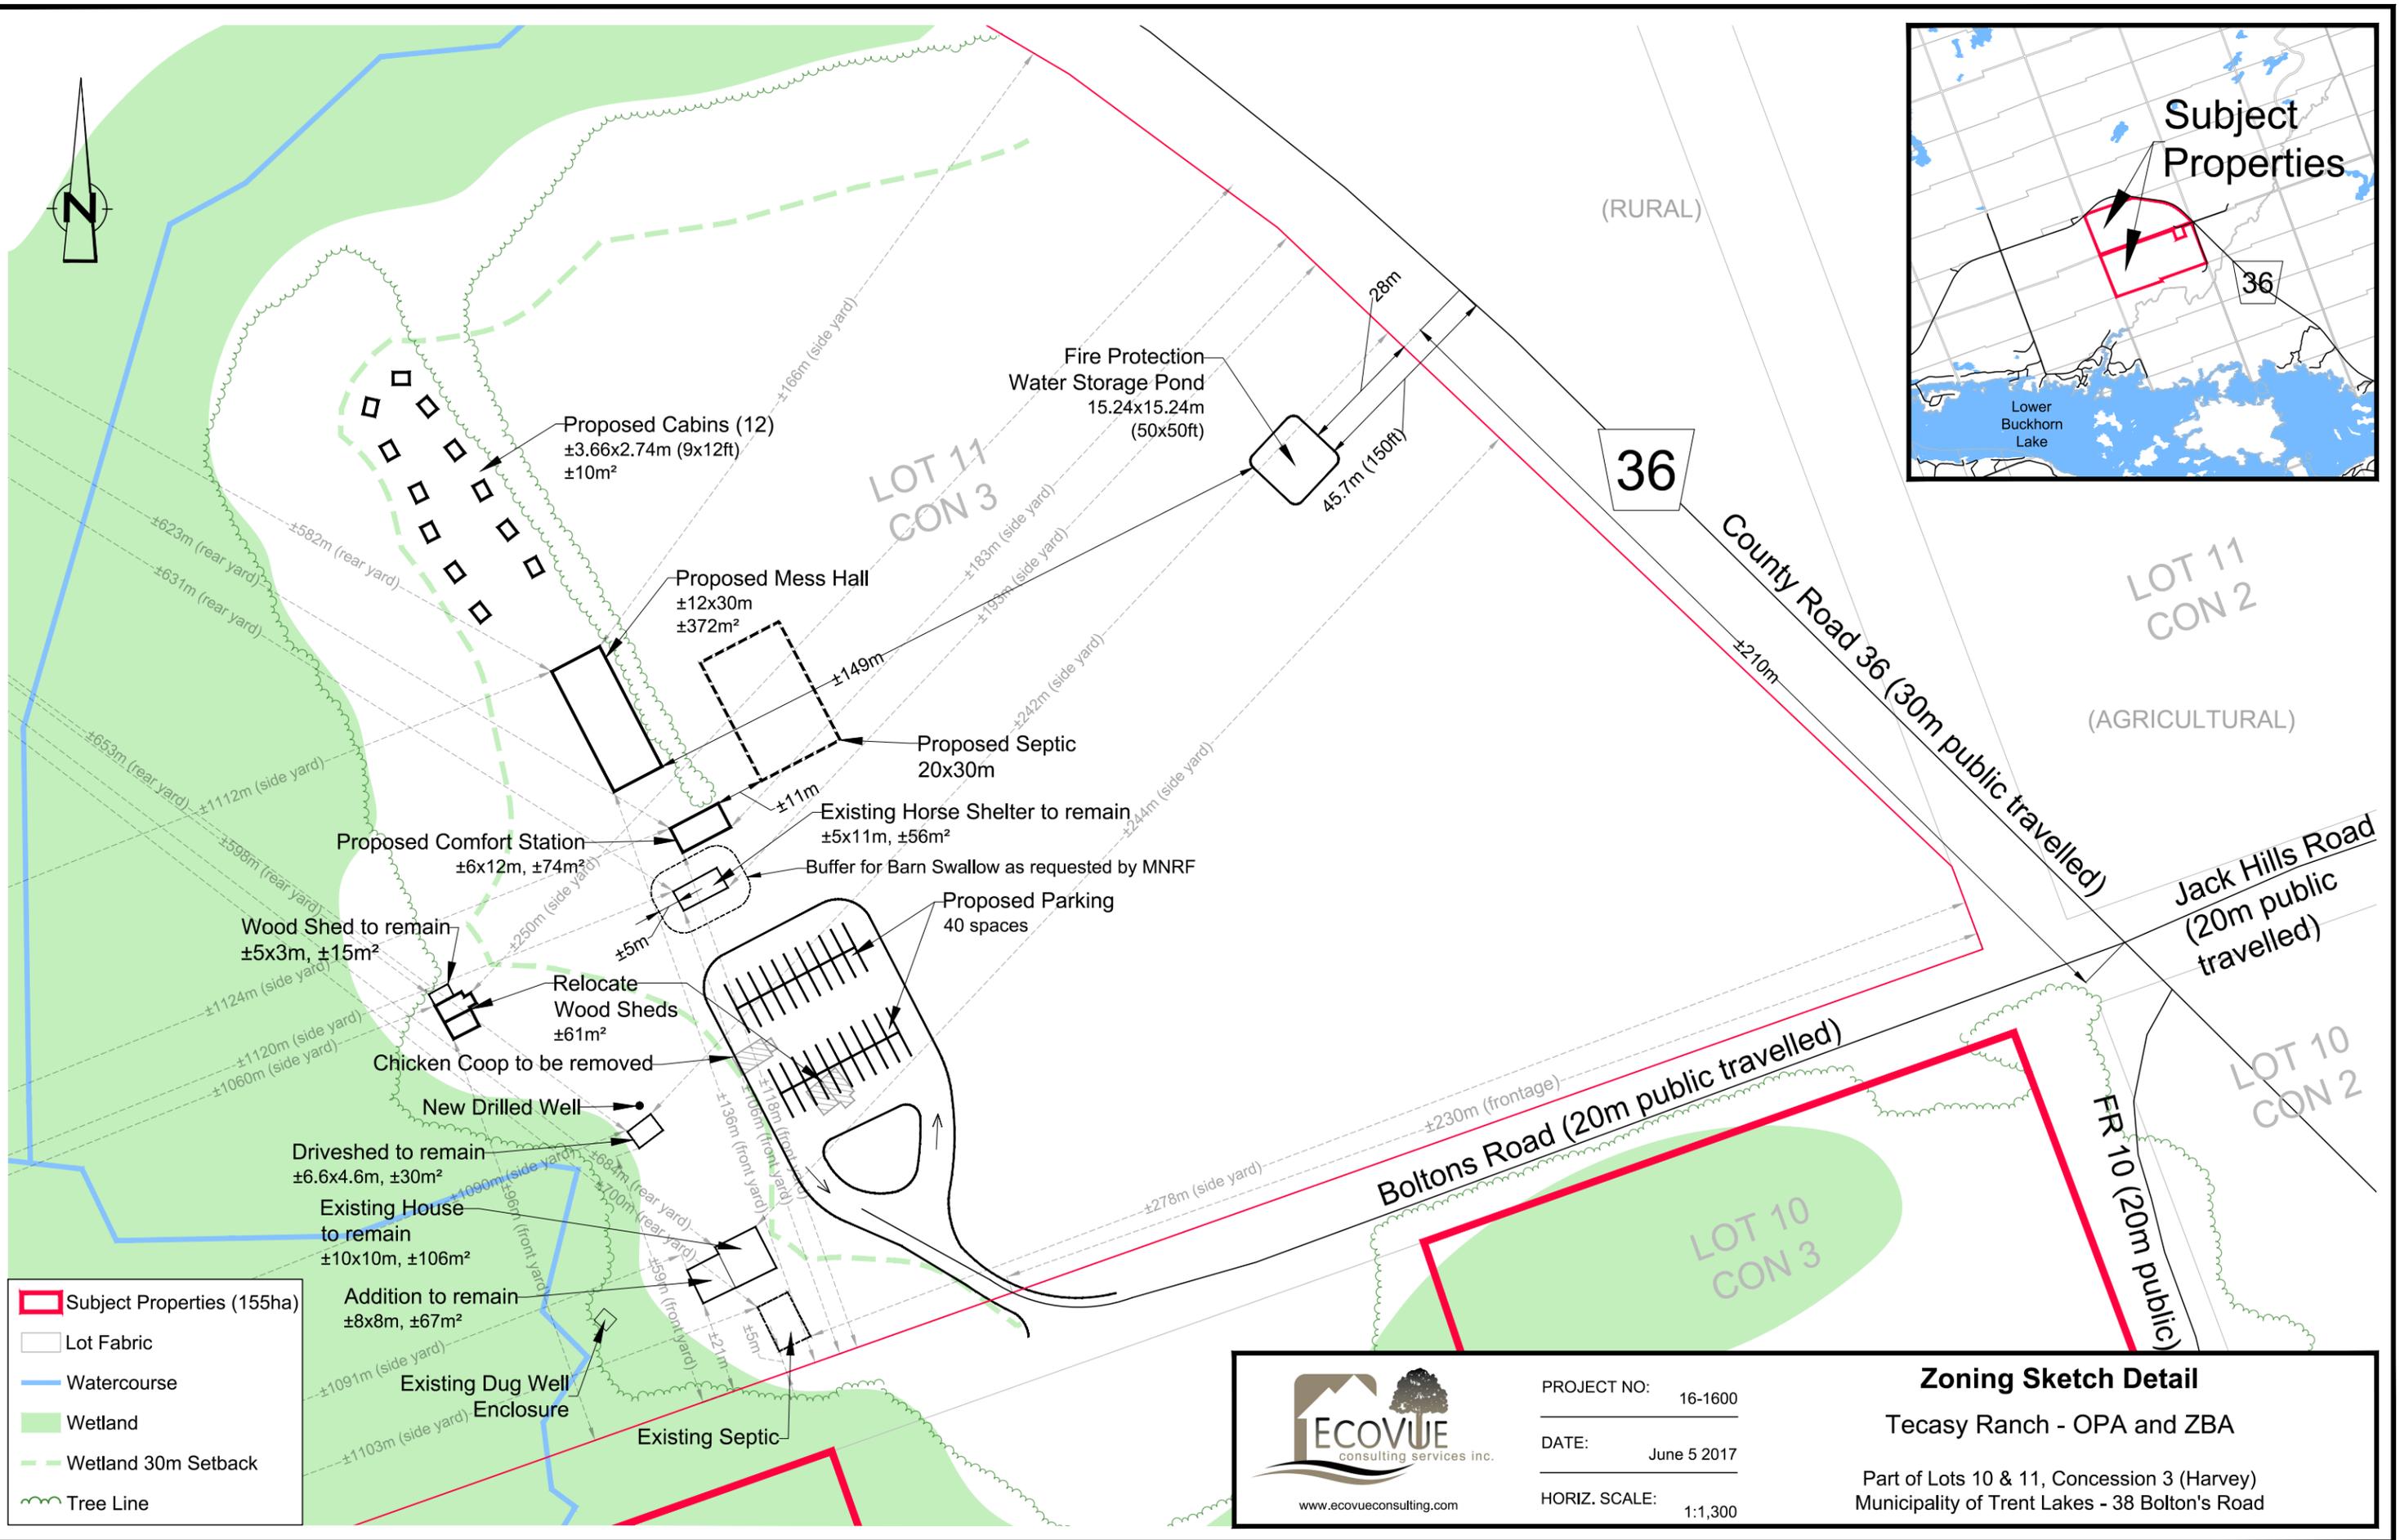
- Subject Properties (155ha)
- Lot Fabric
- Watercourse
- Wetland
- Wetland 30m Setback
- Tree Line

Cambium has provided additional information and conducted additional surveys at the Site in order to fully address the comments provided by the MNRF. An updated Site Plan has been prepared by EcoVue that incorporates the recommendations noted herein. With regards to the

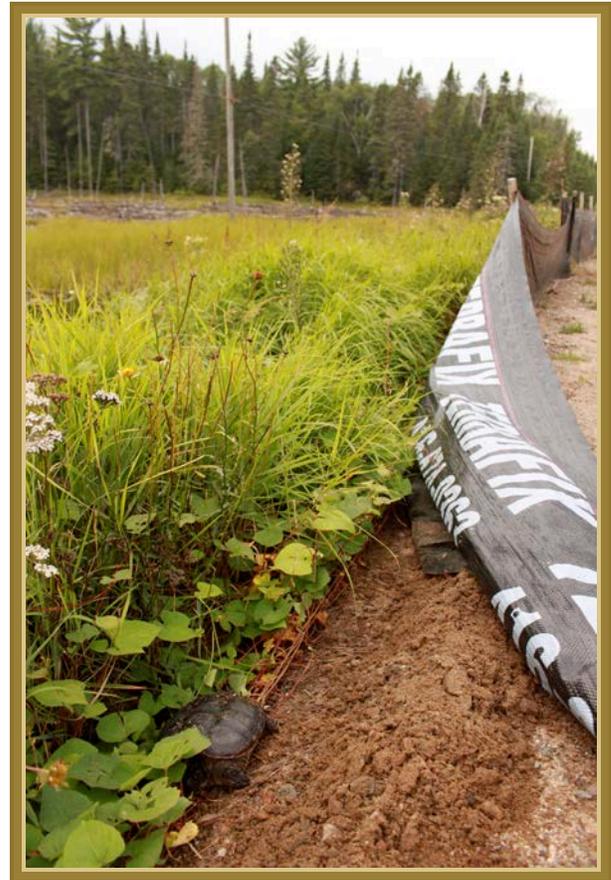
Plate 1. Light-duty geotextile fencing with pre-attached wooden stakes used to exclude turtles from a road as seen on a regular maintenance check (photo credit: Brad Steinberg).

- Fencing fabric is effective if attached to wooden, heavy plastic or metal stakes using heavy-duty wire staples or tie-wire (Figure 2).
- Secure the fence on posts that are placed at 2 m to 3 m apart. If using the greater recommended distance between posts, additional maintenance may be required to maintain effectiveness.

- Securely drive the stakes into the ground to a recommended depth of 30 cm. The fencing fabric should be buried to the recommended specifications in Table 1 and back-filled with soil.

Generally, light-duty geotextile fences are not effective if they exceed 1 metre in height unless purposely manufactured for greater height (e.g. stakes placed at closer intervals or cross braces). If greater height is required consider using heavy duty geotextile, hardware cloth or other fencing materials.

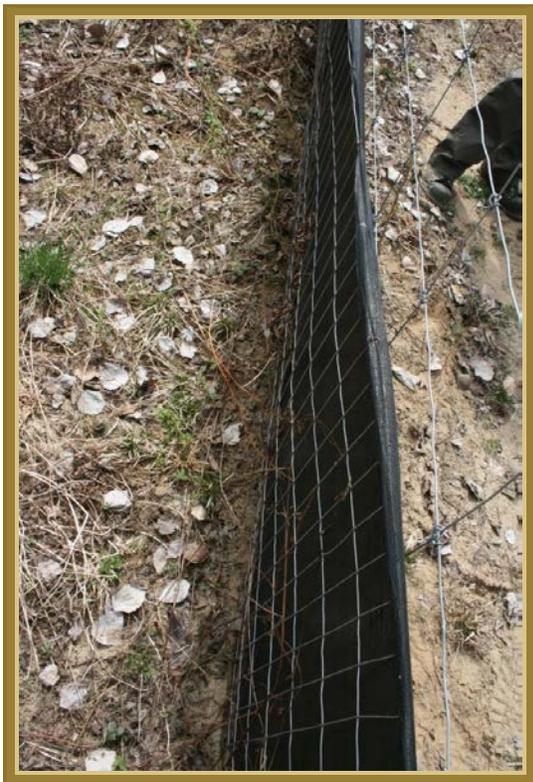
Plate 2. Example of a heavy-duty geotextile fencing used to exclude snake species (photo credit: Jeremy Rouse).

Heavy-duty geotextile fencing is typically constructed of a thick felt-like fabric. It may also be called 'double row' or 'trenched' fencing. For support, this fencing uses a woven wire fence (e.g. chain link) or some other structure (Plate 2). It is recommended that a minimum density of 270R or equivalent woven geotextile fabric is used.

Heavy-duty geotextile material can be effective for up to 2 or 3 years with proper maintenance. This type of fencing can be damaged by small mammals chewing through or torn by heavy debris (e.g. tree branches). Therefore, it may be best suited to turtles, which are less likely to take advantage of holes or tears in the fabric. If

- The wire fence should be installed on the activity side to prevent animals from leveraging and climbing into the exclusion area while allowing the animal to escape if they find themselves on the wrong side (Figure 2).
- Geotextile fences across streams, ditches or waterways should have case-specific modifications.
- Contact your local MNR staff or experienced exclusion fencing contractor for advice.
- See light-duty geotextile section above and general best practices below for additional details.

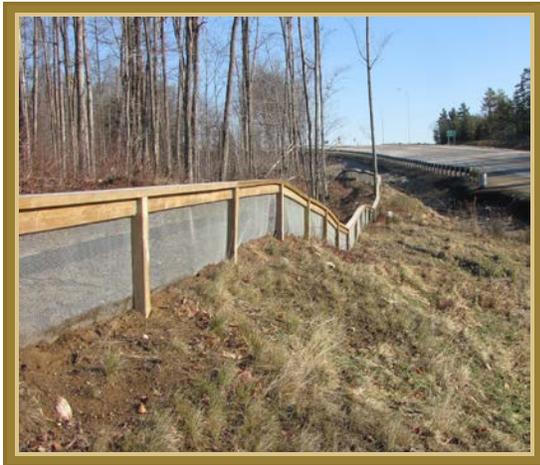
Plate 3. Example of a galvanized mesh fencing used for the long-term exclusion of snakes and turtles from the adjacent highway (photo credit: Megan Bonenfant).

- Secure the fence on posts placed a recommended 2.5 m apart with the stakes on the activity side (Figure 2).
- Pull the mesh taut and staple or secure with screws and a metal stripping to prevent the mesh from being ripped when pressure is applied.
- Installing a top rail or folding the mesh over a taut smooth wire reduces tearing (Plates 3 and 4).
- An outward facing lip installed on the species side ensures that snakes and amphibians are unable to climb or jump over the fence (Figure 2; Plate 4)
- Tears can be mended with 18-gauge galvanized wire.
- See general best practices section below for additional details.

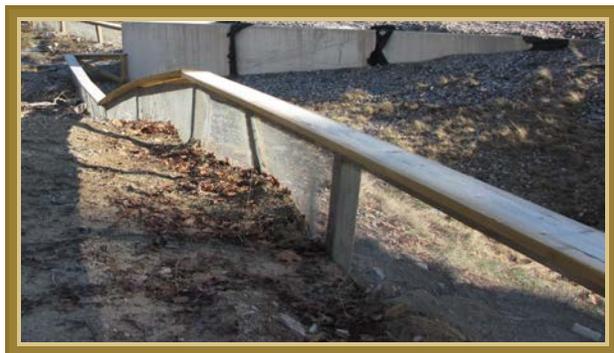
Plate 4. Long-term to permanent exclusion fencing using galvanized mesh with over-hanging lip to prevent animals from climbing or jumping over (photo credit: Megan Bonenfant).

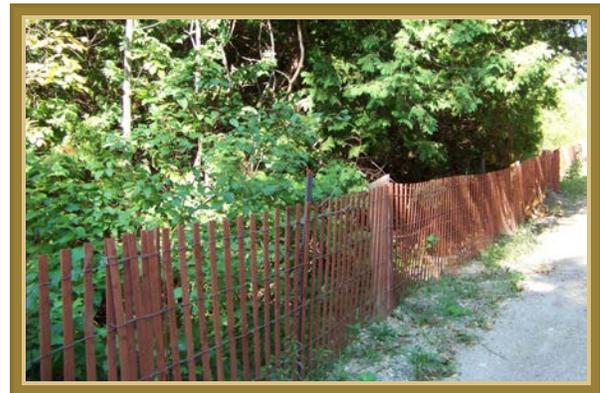
Plate 5. Example of a wood lath snow fencing used to exclude turtles (photo credit: Karine Beriault).

Wood lath fencing is cost effective and can easily be laid down during the winter to prevent damage. The durability of the material, however, is not meant for very long-term use (e.g. more than 3 years), unless regular maintenance occurs.

- The fencing should be attached to heavy plastic or metal stakes using heavy-duty wire staples or tie-wire.
- The stakes are recommended to be placed at 2 to 3 m intervals and securely driven into the ground 30 cm or more.
- Wood lath snow fencing across streams, ditches or waterways should have case-specific modifications.
- Wood lath snow fencing lends itself well to being combined with other types of material to ensure complete exclusion.
- See general best practices section below for additional details.

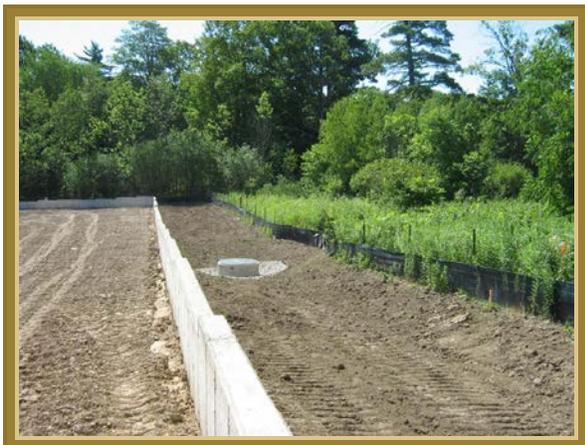
Plate 6. Stand-alone continuous concrete wall used to exclude salamander species installed as pre-cast forms (photo credit: Steven Roorda).

Concrete, metal or vinyl walls can stand alone or be combined with woven wire or chain link fences. They are durable, require minimal maintenance and are effective in excluding target species from high risk areas and guiding them to crossing structures or other desired locations (Plates 6 and 7). This fence type is comprised of a continuous vertical face of concrete, metal or vinyl sheeting with no gaps. Concrete walls can be installed as either pre-cast sections or pour directly in place.

The wall height depends upon the target species, but they are usually between 45 and 60 cm tall and buried 25 cm. Concrete, metal or vinyl exclusion fencing is most appropriate for salamanders, skinks, small snakes, and small turtles. For large turtle species, a chain link fence can be installed directly on top of the concrete wall for complete exclusion.

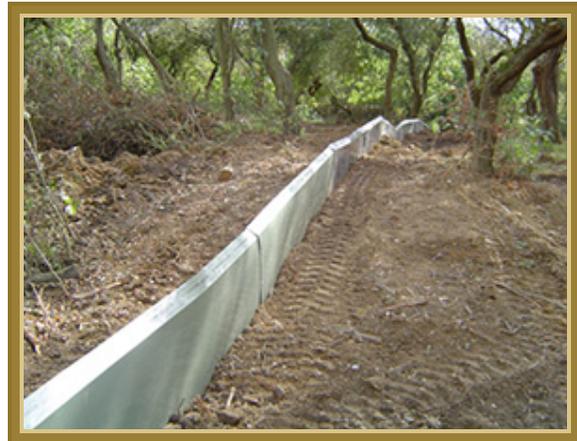
Plate 7. Pre-formed vinyl sheeting fence intended to exclude salamanders for a construction site (photo credit: Herpetosure Ltd.)

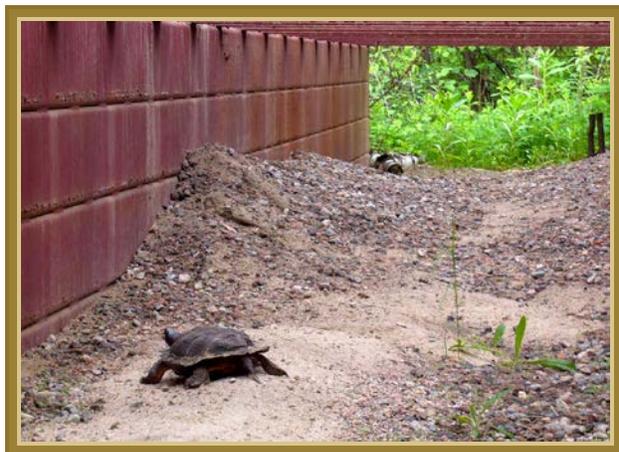
Plate 7. A wood turtle travelling through a dry eco-passage. Ecopassages such as this help to ensure the long-term connectivity of seasonal habitat for this and other reptile and amphibian species (photo credit: Amy Mui).

During the installation of fencing with an eco-passage, it is important that the fencing sits flush with the passage to ensure that

there are no gaps where animals can squeeze through.

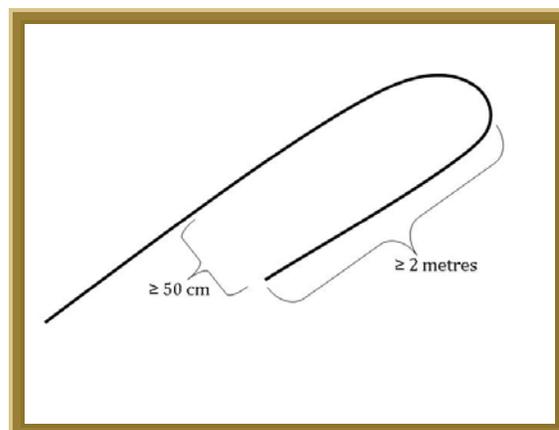
Figure 1. Diagram of the ends of the fence designed to curve inward in order to direct animals away from the area of exclusion.

- Install fences with a turn-around at the ends furthest from the wetland habitat and at any access areas to assist in redirecting animals away from any fence openings (Figure 1).

- Curving the ends of the fencing inward (i.e. away from the road or construction site) may help to reduce access to these locations. The ends may also be tied off to natural features on the landscape such as trees or rock cuts.

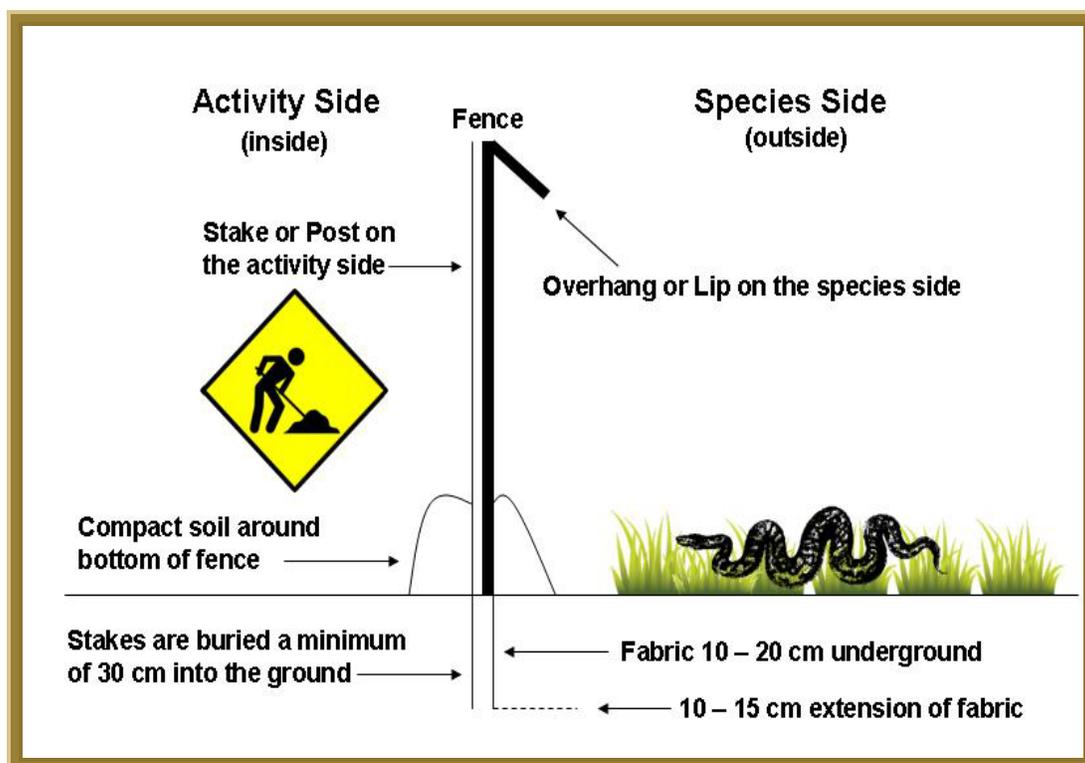
Figure 1. A side view of a basic exclusion fence including an overhang or flexible lip to deter animals from climbing or jumping over the fence. Placement of the stake on the Activity Side or on the inside of excluded area is also illustrated. This is particularly important for snake species which may use the stakes to maneuver over the fence.
