May 29, 2024 MTE File No.: C55367-100

RE: Aggregate Assessment – Desktop Review 135 Tate's Bay Road, Trent Lakes Lot 19 Concession 14, Harvey Township, Ontario

MTE Consultants | C55367-100 | Aggregate Assessment - 135 Tates Bay Road, Municipality of Trent Lakes, Ontario

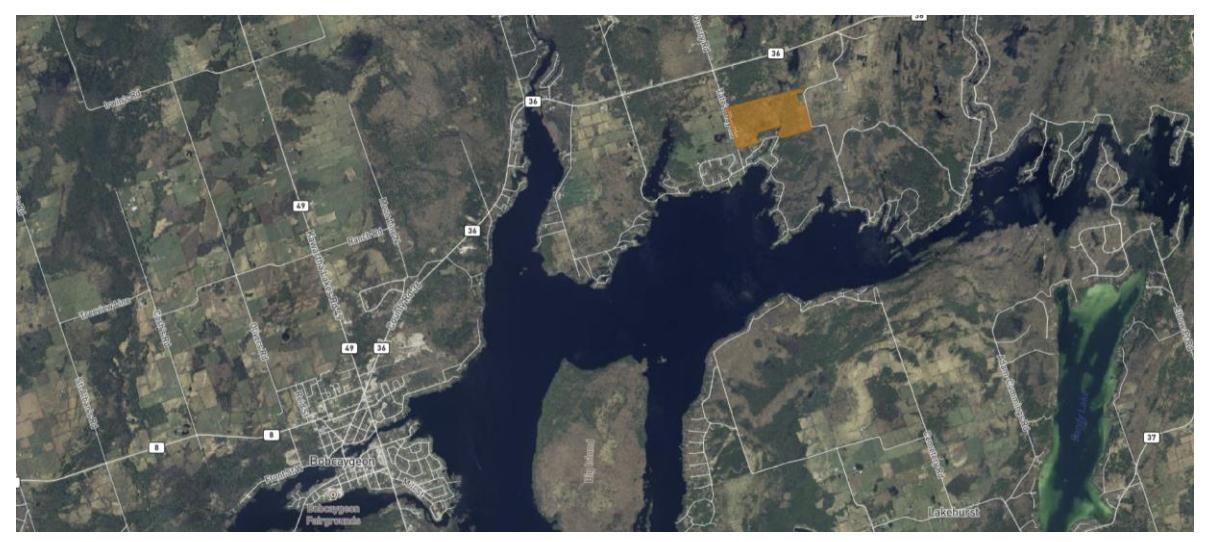
Insert 1: Site Location

MTE Consultants Inc. (MTE) was retained by TD Consulting Inc. to conduct a desktop aggregate assessment for the property located at 135 Tate's Bay Road, Trent Lakes, Lot 19 Concession 14, Harvey Township, Ontario (hereby referred to as the 'Site'). Insert 1 below shows the Site location approximately seven kilometres northeast of Bobcaygeon, ON. The Official Plan for the Municipality of Trent Lakes shows that the southwest corner of the Site is designated as Aggregate Resource Extraction (see Schedule A1 of the Official Plan) hereby referred to as the "designated area" (see Insert 2).

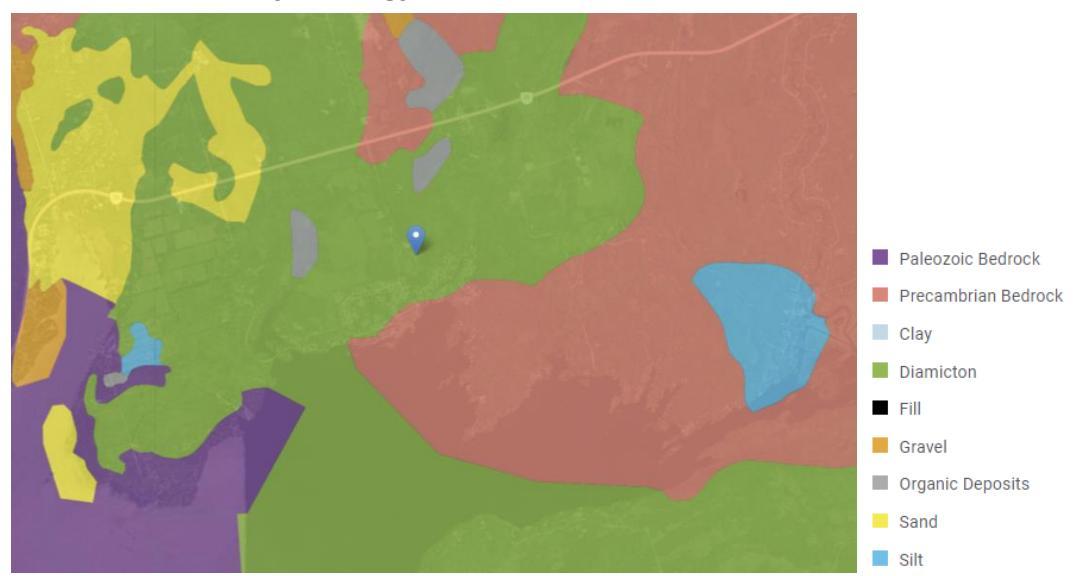
Insert 4: Quaternary Geology

Quaternary Geology mapping shows that the Site is underlain by diamicton or undifferentiated till, predominately sand matrix, extremely stony, boulders, and high in total matrix carbonates, often associated with stratified sediments (See **Insert 4**). The presence of till deposits introduces fine material such as silt and fine sand to the aggregate deposit that may require washing before it can be sold as an aggregate product. Aggregate washing increases the value of the aggregate product but requires additional Permitting (i.e. a Permit to Take Water) from the Ministry of the Environment, Conservation and Parks (MECP) which may affect the economic feasibility of extracting the aggregate.

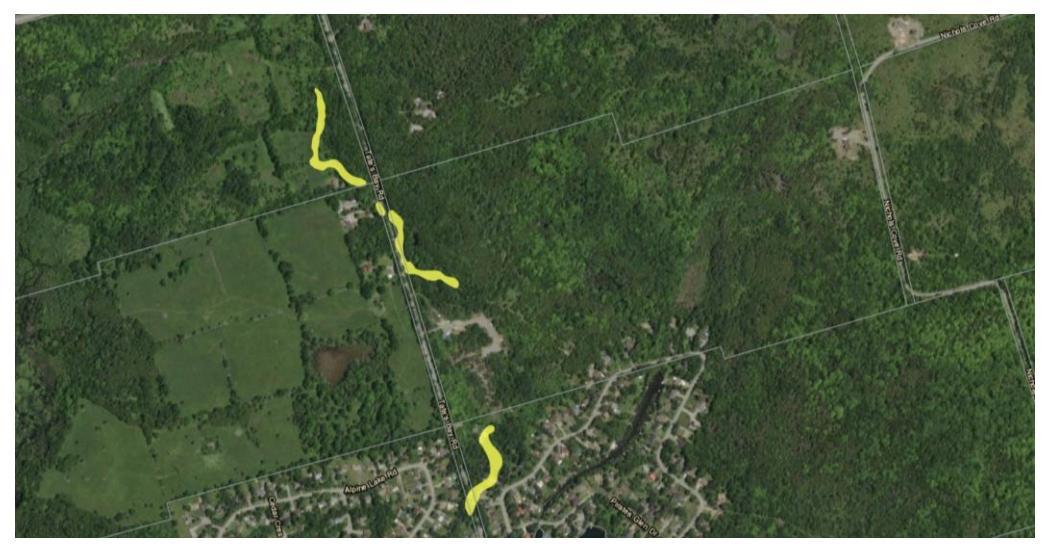
Insert 5: Aggregate Resource Inventory

A review of ARIP 105 for Peterborough County (Ontario Geological Survey, 2019) indicates that much of the area around the Site is unevaluated (See **Insert 5**). There is a narrow band of resource of Tertiary significance along Tates Bay Road near Site but the rest of the Site is unevaluated. From the mapping, there is a gap in the band of Tertiary significance where it crosses the Site, likley because it has already been extracted by historical pit activity. Test pits may be requried to confirm presence or absence of the remaining reserve. ARIP 105 suggests that this aggregate deposit is classified as either sand deposits, generally less than three meters thick, or mixed sand and gravel deposits less than 1.5m thick.

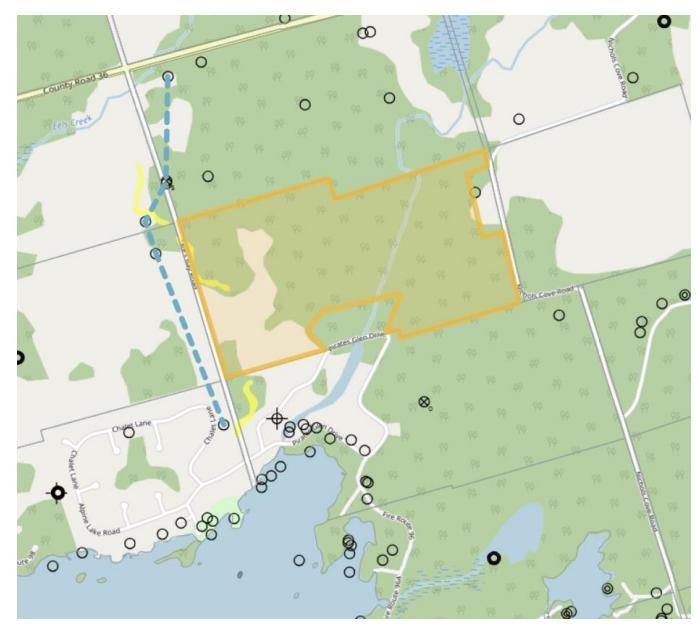
Insert 6: Water Well Records within 500m

A review of MECP well records within 500 meters (see **Insert 6**) showed that the surficial soils range between clay and gravel. The thicknesses of potential aggregate (boulders and sand) ranges between three meters to five meters (see red circles on **Insert 7**). Underlying bedrock composition is Granite.

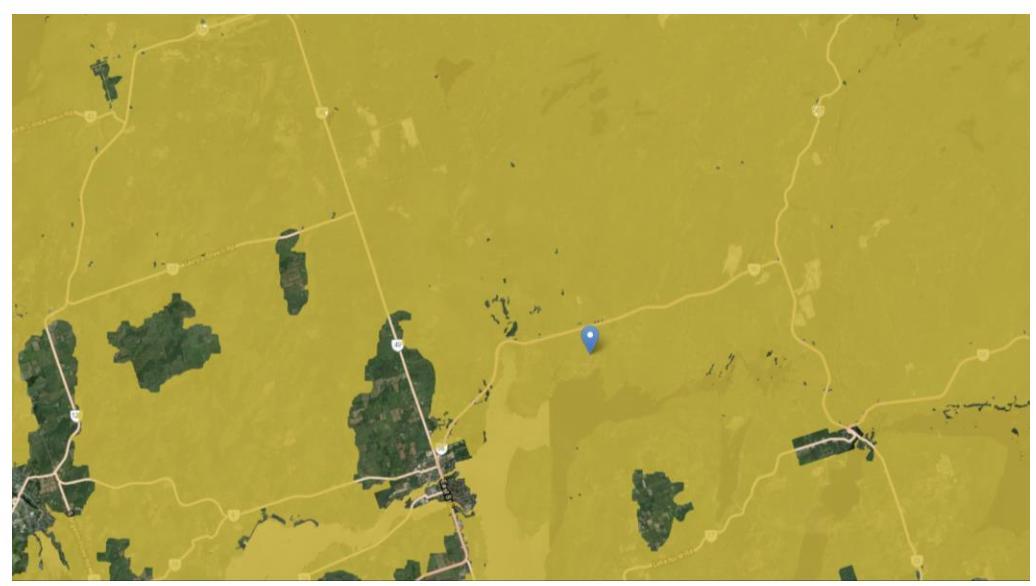
Insert 8: Natural Heritage System Mapping

According to the Growth Pan for the Greater Golden Horseshoe, the Site is mapped as Natural Heritage System (see **Insert 8**), which means a new aggregate license can only be permitted if the application was for an expansion of an existing license. Since the Site is not currently licensed, it cannot be permitted under this policy, regardles of the designation in the Official Plan.

- Existing land use such as the Growth Plan for the Greater Golden prohibits new aggregate licenses in areas mapped as Natural Heritage System. Given this prohibition, it is not feasible to license any portion of the designated area.

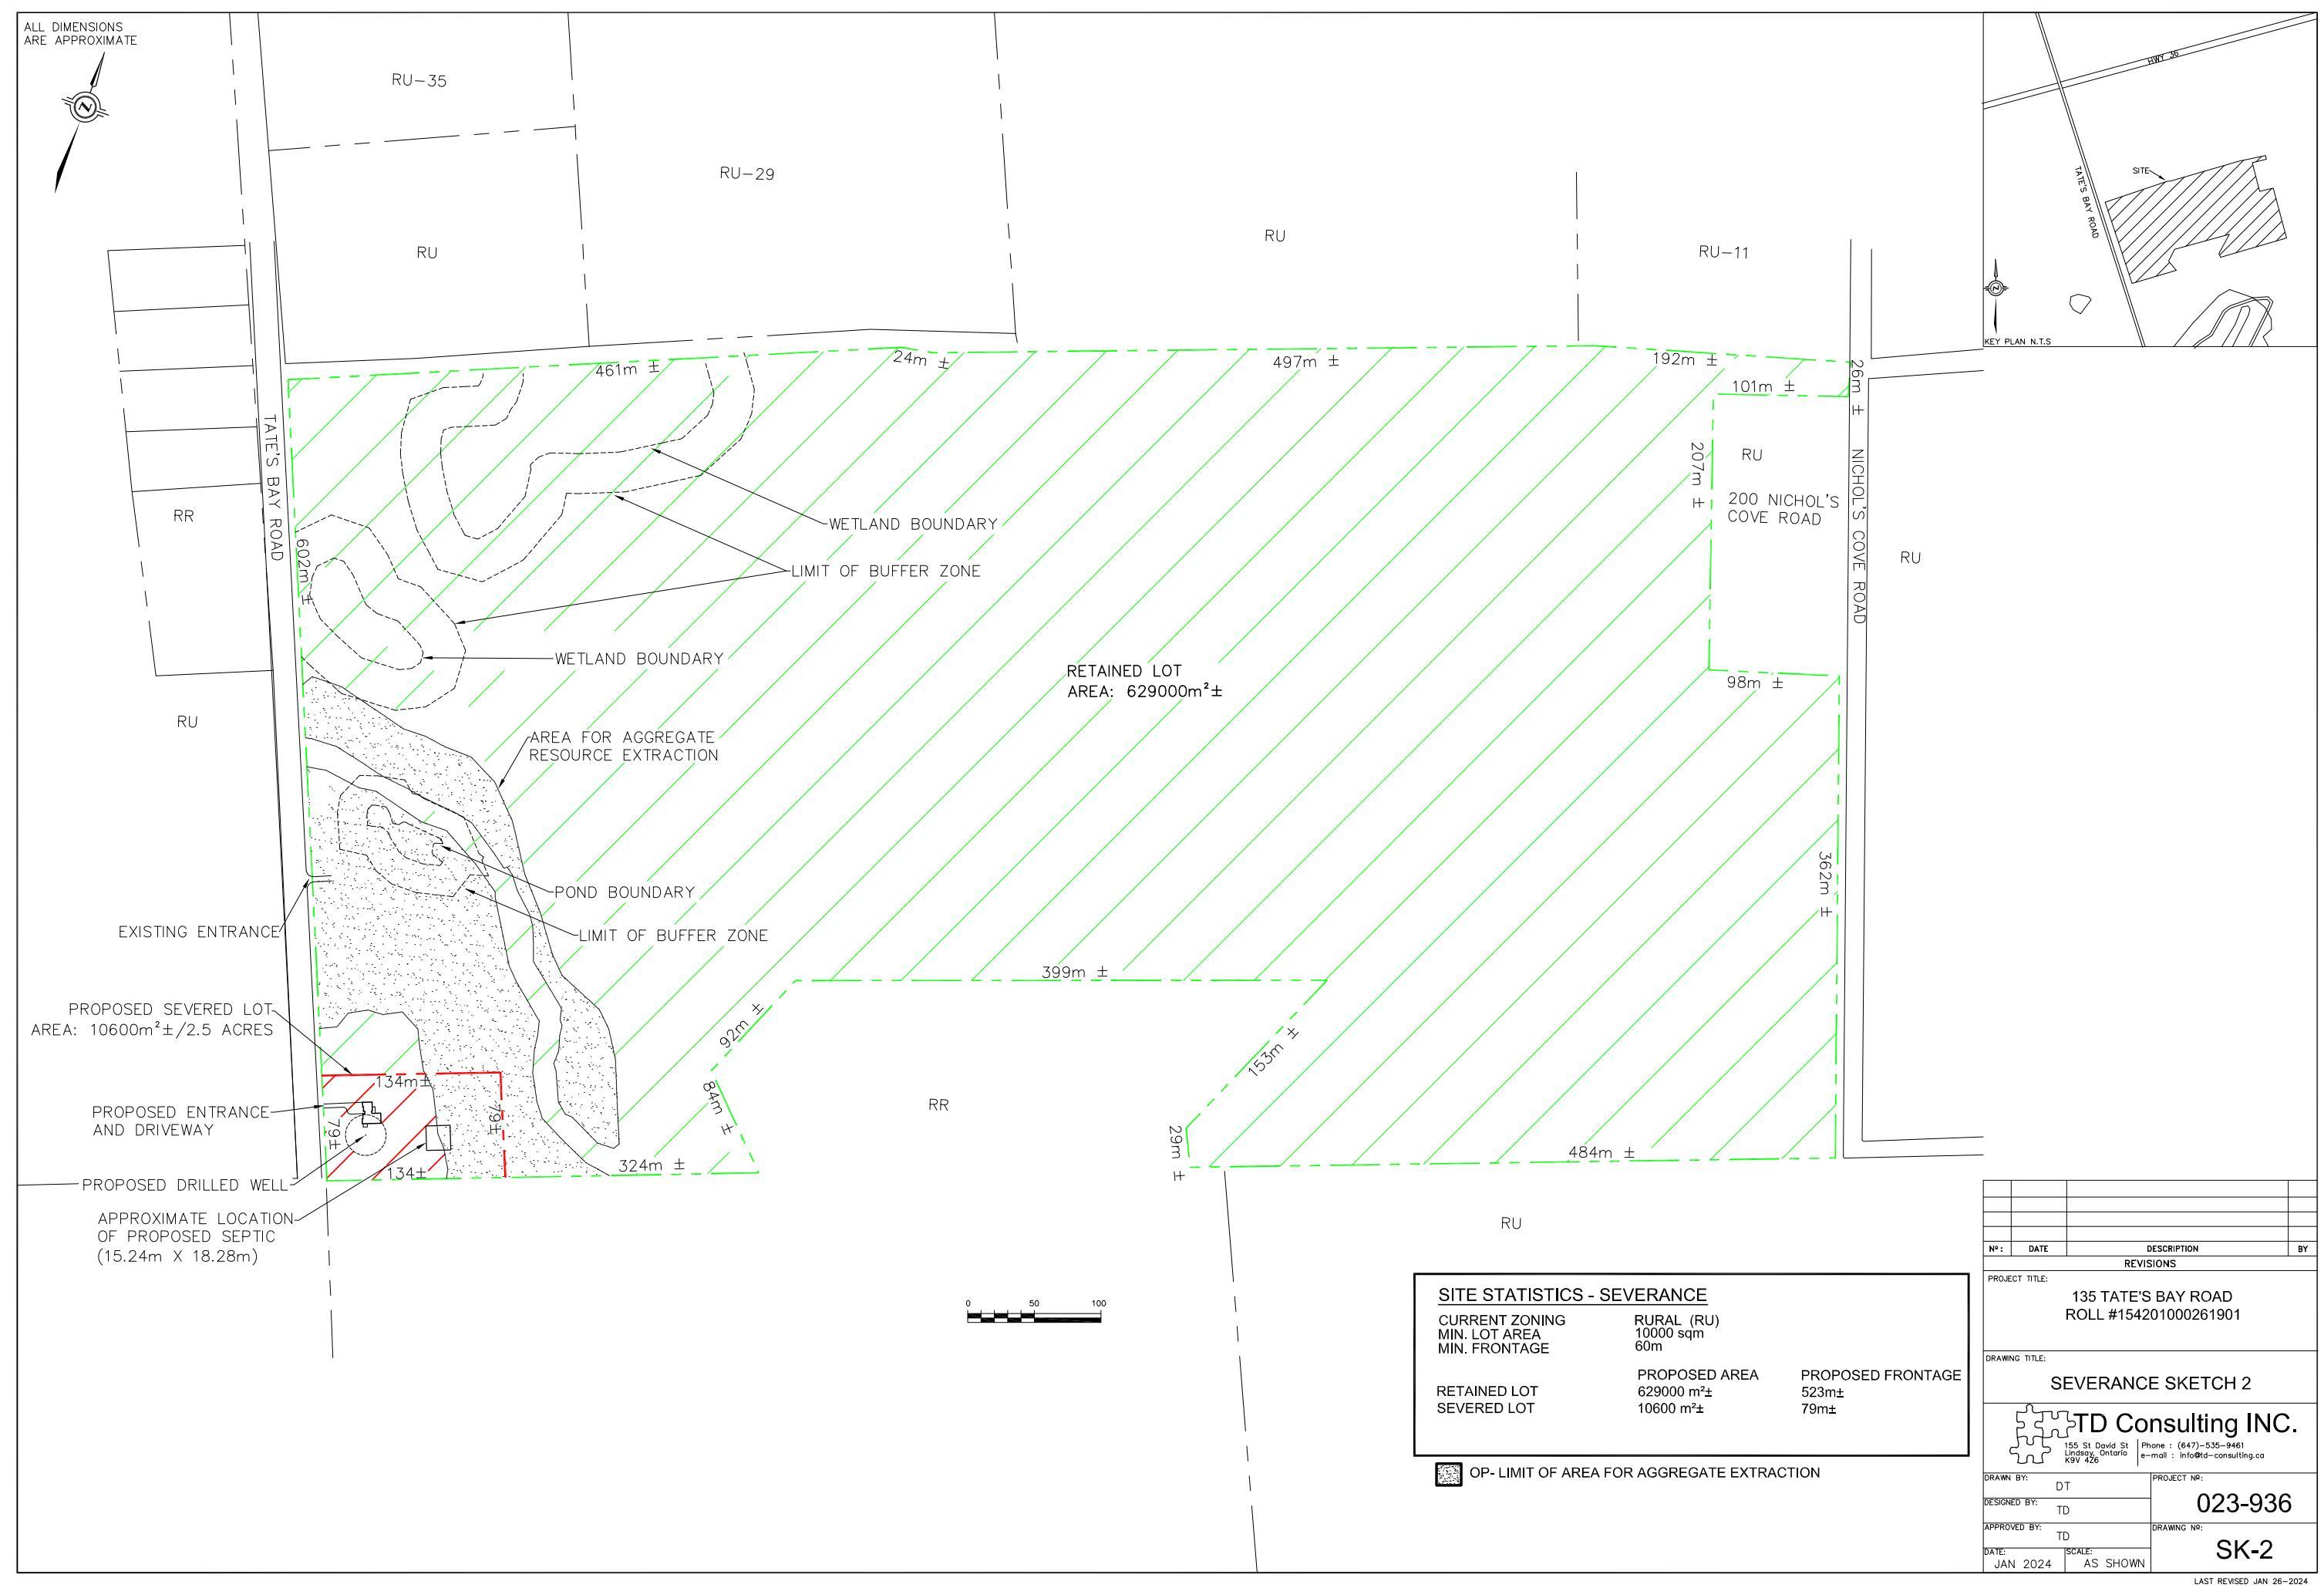
TD Consulting INC (2024). Severance Sketch 2 Roll #154201000261901.

MTE understands that a Lot severance application has been submitted to the Township of Trent Lakes for a small portion (1.06 Ha) of the Site located in the southwest corner (see severance sketch attached). This desk-top study will assess the potential impact of the Lot severance on the designated area and discuss the feasibility of obtaining an aggregate License under the Aggregate Resources Act (ARA) for this portion of the Site.

The proposed Lot severance overlaps a portion of the designated area. Considering this overlap, the Lot severance may sterilize approximately 13,275 tonnes (5%) of aggregate resource (see **Table 1**).
